New Hampshire Volunteer Lake Assessment Program

2002 Bi-Annual Report for Lake Massasecum Bradford

Lake Massasecum, Bradford

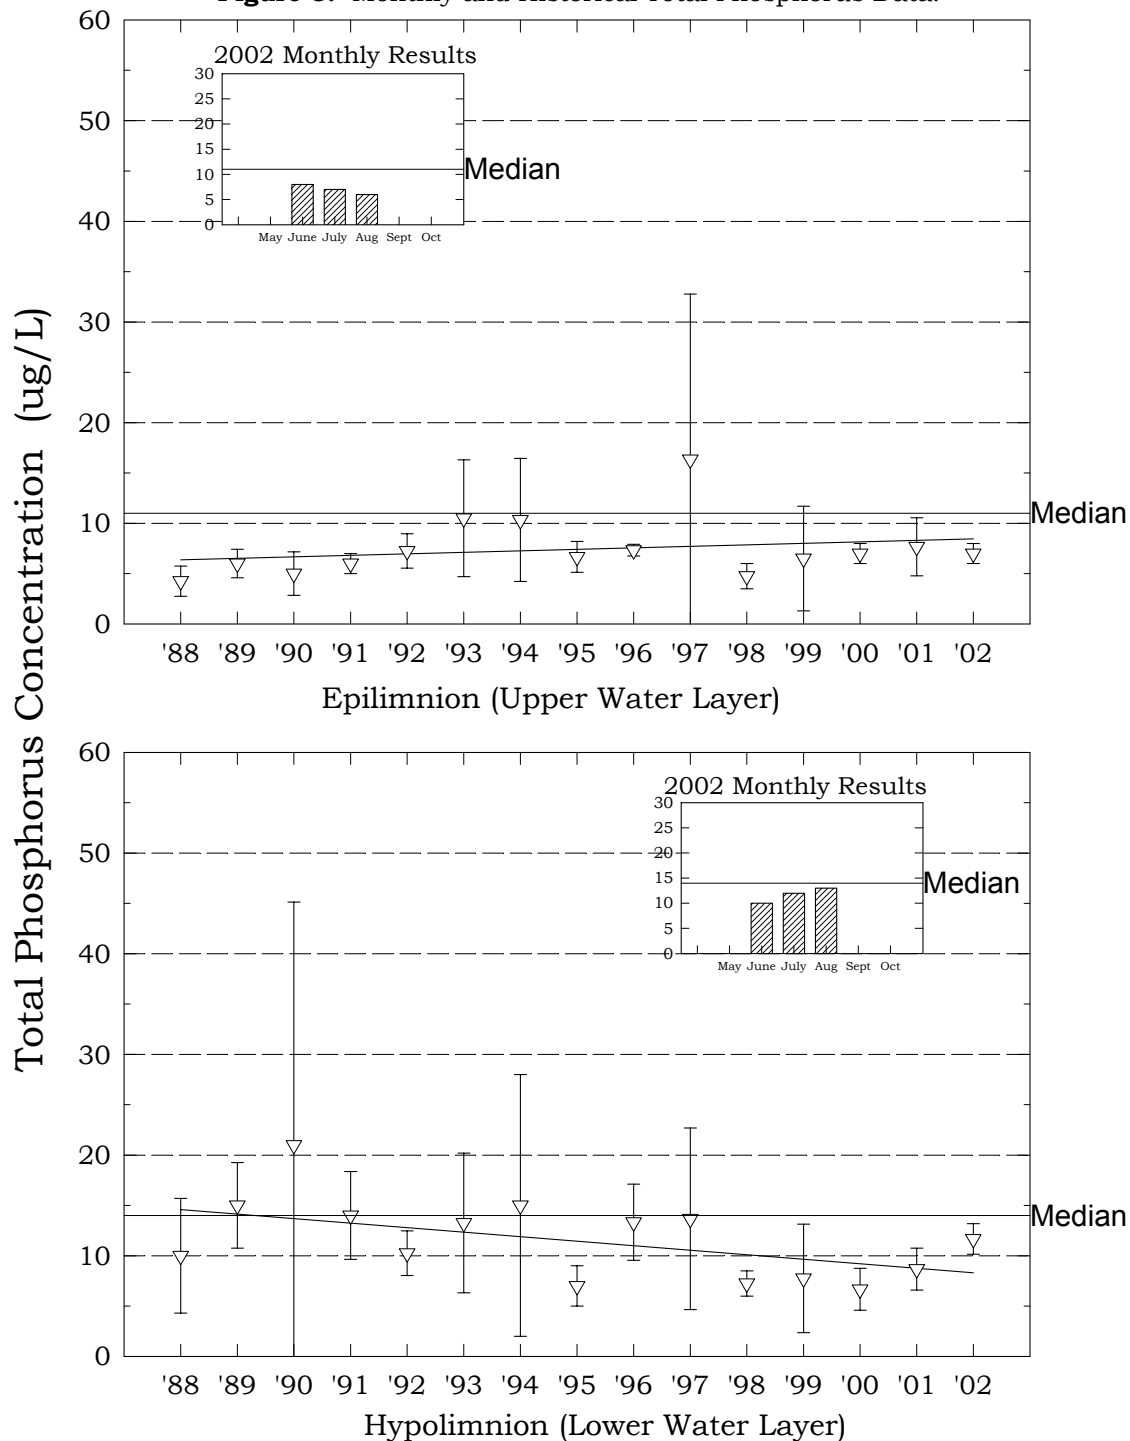
Figure 3. Monthly and Historical Total Phosphorus Data.

The current year data for the epilimnion (the top inset graph) show that the total phosphorus concentration **decreased gradually** from June to August.

The historical data show that the 2002 mean epilimnetic total phosphorus concentration is **less than** the state median.

The current year data for the hypolimnion (the bottom inset graph) show that the total phosphorus concentration **increased gradually** from June to August.

The historical data show that the 2002 mean hypolimnetic total phosphorus concentration is **less than** the state median.

Overall, the statistical analysis of the historical data show that the total phosphorus concentration in the epilimnion (upper layer) has **not significantly changed** (either *continually increased* or *decreased*) since monitoring began in **1988**. Specifically, the total phosphorus concentration in the epilimnion has remained **relatively stable** and has been **less than** the state median. (Note: Please refer to Appendix E for the statistical analysis explanation and data print out.)

Overall, the statistical analysis of the historical data show that the total phosphorus concentration in the hypolimnion (upper layer) has **fluctuated** since monitoring began in **1988**. Specifically, the total phosphorus concentration in the epilimnion has **varied** since monitoring began (Note: Please refer to Appendix E for the statistical analysis explanation and data print out.)

One of the most important approaches to reducing phosphorus loading to a waterbody is to continually educate watershed residents about its sources and how excessive amounts can adversely impact the ecology and value of lakes and ponds. Phosphorus sources within a lake or pond's watershed typically include septic systems, animal waste, lawn fertilizer, road and construction erosion, and natural wetlands. If you would like to educate watershed residents about how they can help to reduce phosphorus loading into the lake/pond, please contact the VLAP Coordinator.
